# Manhole Inspection Summary

Manhole # S53K\_\_030MH

Insp Date: **4/8/08 3:24 PM**

**Location** Address: **701 Foster Alley Fait**

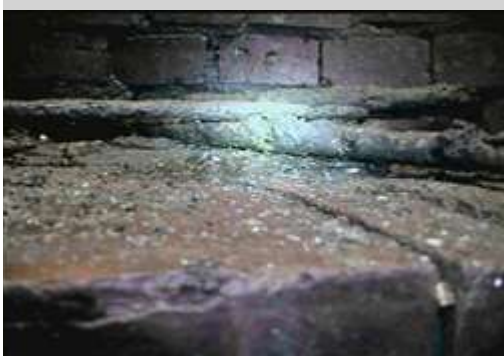
Defect 4

Condition: ☐ Sound ☐ Cracked ☐ Root Intrusion ☐ Deteriorated ☐ Leaks ☒ **Debris**

bench debris

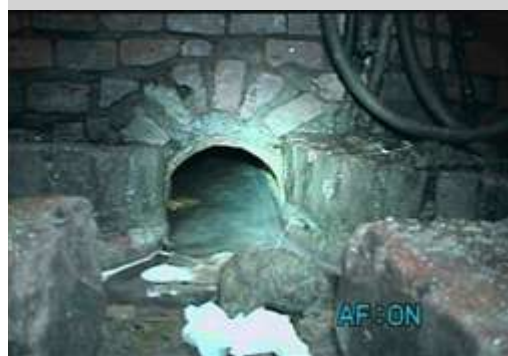
Defect 3

Condition: ☐ Sound ☐ Cracked ☐ Root Intrusion ☐ Deteriorated ☐ Leaks ☒ **Debris**

channel debris

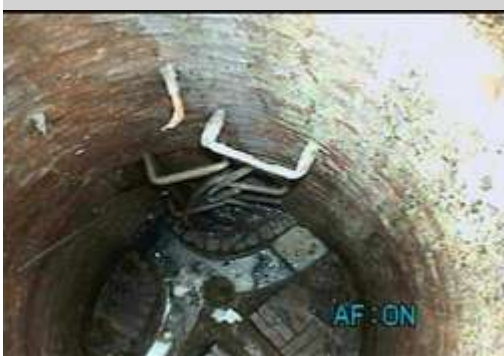
Defect 2

**Steps** Count: **6** Missing: **2** ☒ **Corroded**

corroded stairs

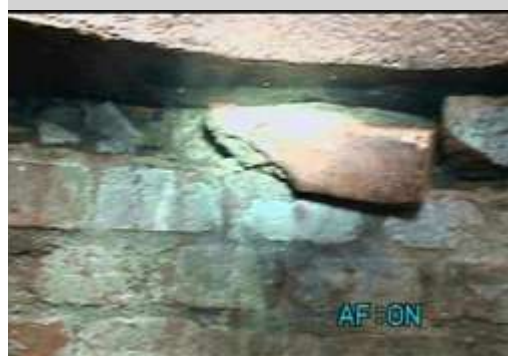
Defect 1

Condition: ☐ Sound ☐ Cracked ☐ Root Intrusion ☒ **Loose Brick** ☐ Deteriorated

chimney cond loose brick

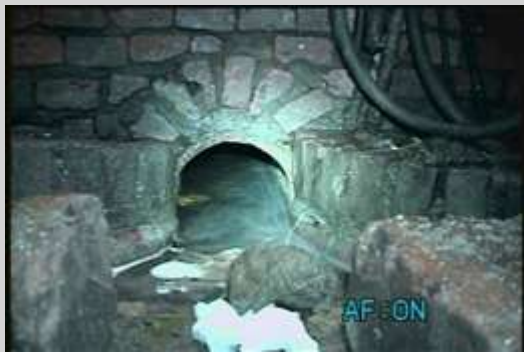
12 O'Clock Outflow

8 in. Circular Gravity Sewer  
Pipe Out @ 12 O'Clock

Pipe Material: **Clay** ☐ Pipe Lined

Invert Depth: 9.10 (ft.) Flow Characteristics: **Slow**

Infiltration: **None** Pipe Seal Cond: **Unknown**

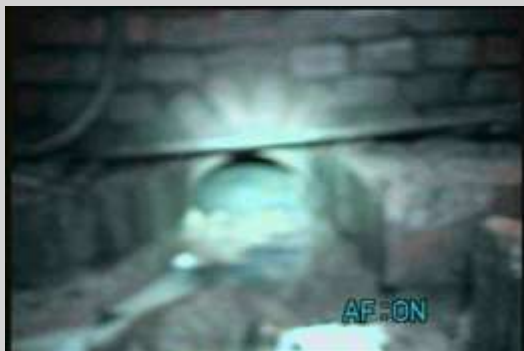
3 O'Clock Inflow

8 in. Circular Gravity Sewer  
Pipe In @ 3 O'Clock

Pipe Material: **Clay** ☐ Pipe Lined

Invert Depth: 9.00 (ft.) Flow Characteristics: **Fast**

Infiltration: **None** Pipe Seal Cond: **Unknown**

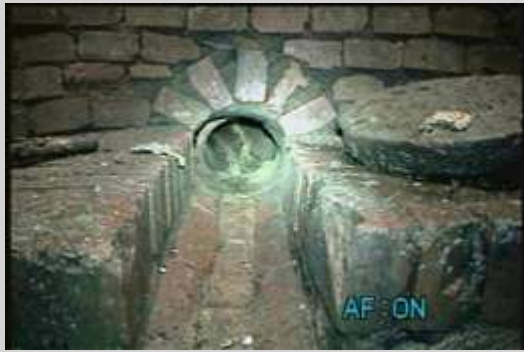
6 O'Clock Inflow

Pipe In @ 6 O'Clock

Pipe Material: **Clay** ☐ Pipe Lined

Invert Depth: **8.80** (ft.) Flow Characteristics: **None**

Connects To: **House connection / Service line**

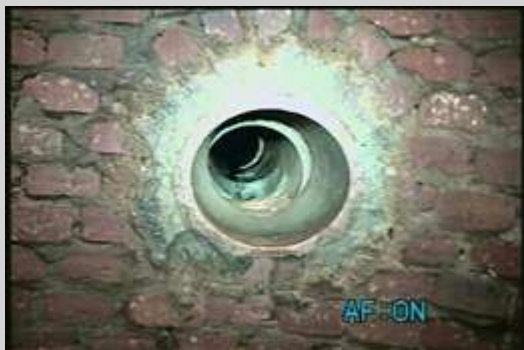
9 O'Clock Inflow

Pipe In @ 9 O'Clock

Pipe Material: **Clay** ☐ Pipe Lined

Invert Depth: **6.80** (ft.) Flow Characteristics: **Slow**

Infiltration: **None**

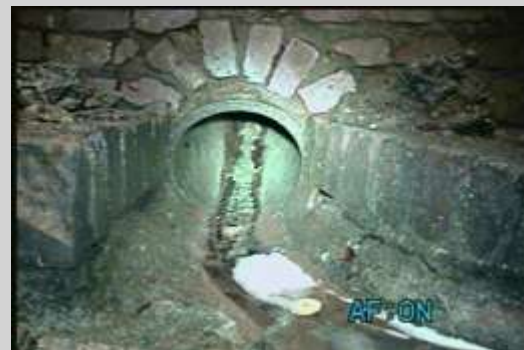
Drop In @ 9 O'Clock

Drop: **Outside Direct**

Inv Depth: **9.83** (ft.)

Drop Condition: **Open**
